**DEPARTMENT OF TRANSPORTATION**

Contract #: 04-0120F4Cty: SF/ALA Rte: 80 PM: 13.2/13.9File #: 1.28**WELDING INSPECTION REPORT****Resident Engineer:** Pursell, Gary**Address:** 333 Burma Road**City:** Oakland, CA 94607**Report No:** WIR-015740**Date Inspected:** 19-Jul-2010**Project Name:** SAS Superstructure**OSM Arrival Time:** 1000**Prime Contractor:** American Bridge/Fluor Enterprises, a JV**OSM Departure Time:** 1830**Contractor:** American Bridge/Fluor Enterprises, a JV**Location:** Job Site

## WELDING INSPECTION REPORT

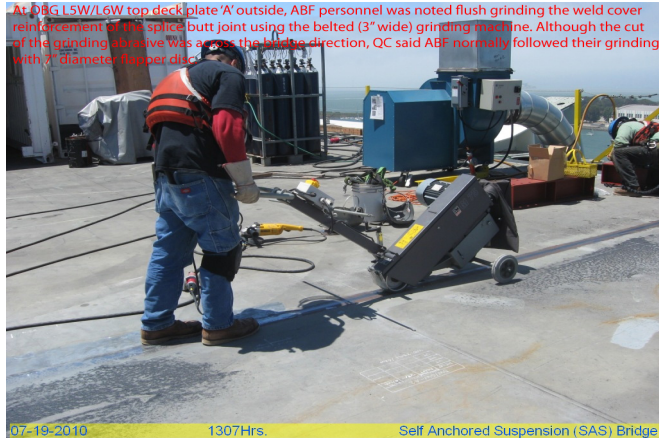
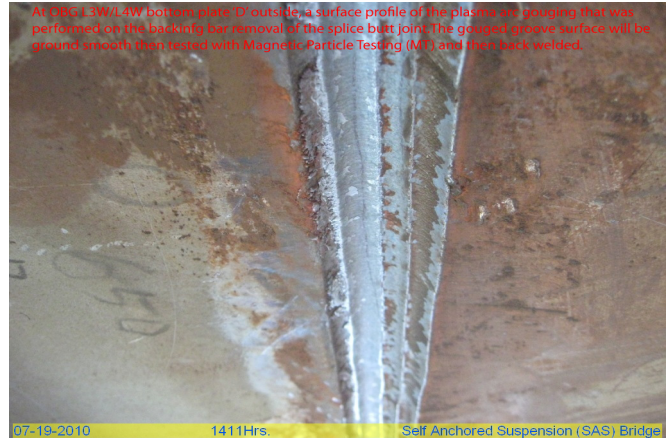
die grinder. The gouged backing bar removal was previously gouged using the track mounted plasma arc machine. Also at OBG L2W/L3W bottom plate 'D' outside, the flush grinding on the cover reinforcement was seen completed. It is now awaiting visual test (VT) to be followed by Magnetic Particle Testing (MT) and Ultrasonic Testing (UT) from the QC if the VT is acceptable.
